## **RESERVE ACTIVITY PLAN 2012-2016**

### **Clifton Beach Coastal Reserve**

Advice prepared by Tasflora  
for Clarence City Council  
July 2012

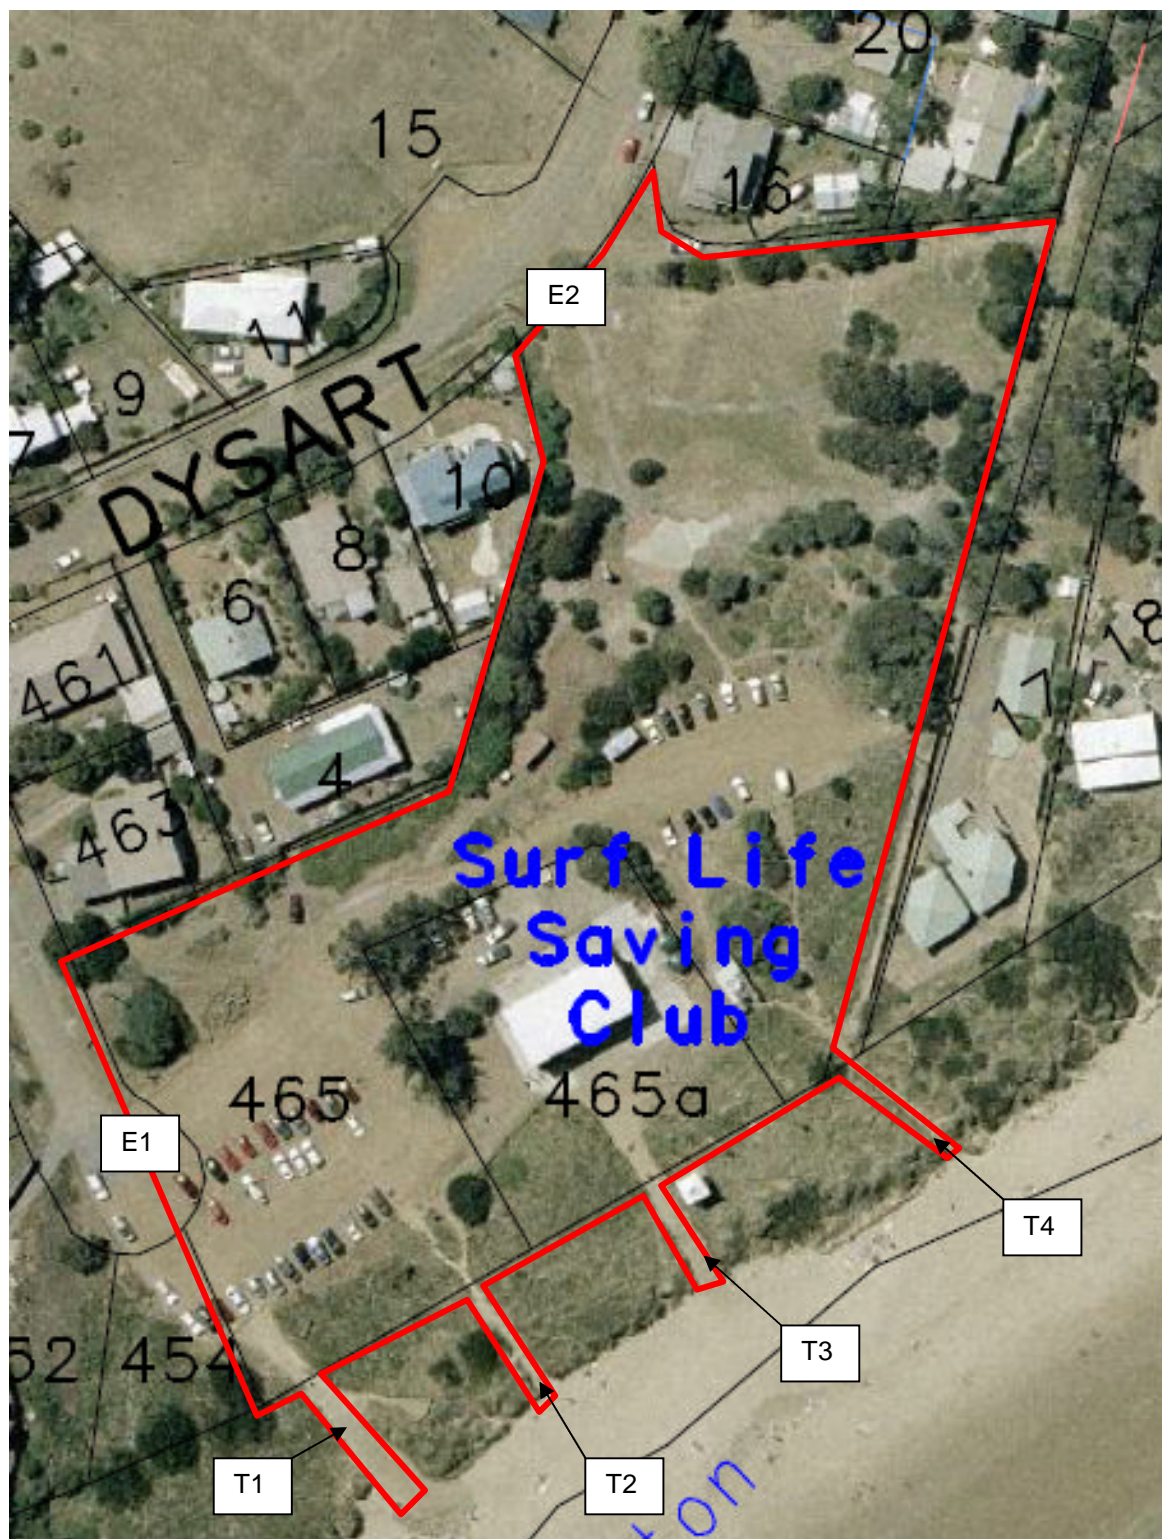
**Figure 1:** Area covered by the *Clifton Beach Coastal Reserve Activity Plan 2012-2016*, including beach access tracks (T1-4) and main entrances (E1-2).<sup>2</sup>

The area covered by this management plan includes the Clifton Beach Reserve and the four formalised access tracks (T1-4) leading through the dunes from the Reserve to Clifton Beach, as illustrated in Figure 1.<sup>1</sup> Council owns and manages the Reserve, and is also responsible for the management of the beach access tracks under a Crown licence.

Infrastructure within the Reserve includes two car parks, a toilet block, a playground and picnic area. Facilities for the Clifton Beach Surf Lifesaving Club (CBSLSC), including a clubhouse building and car park, are also located within the Reserve. There are two main entrances to the Reserve from Clifton Beach Road (E1) and Dysart Street (E2) as illustrated in Figure 1.

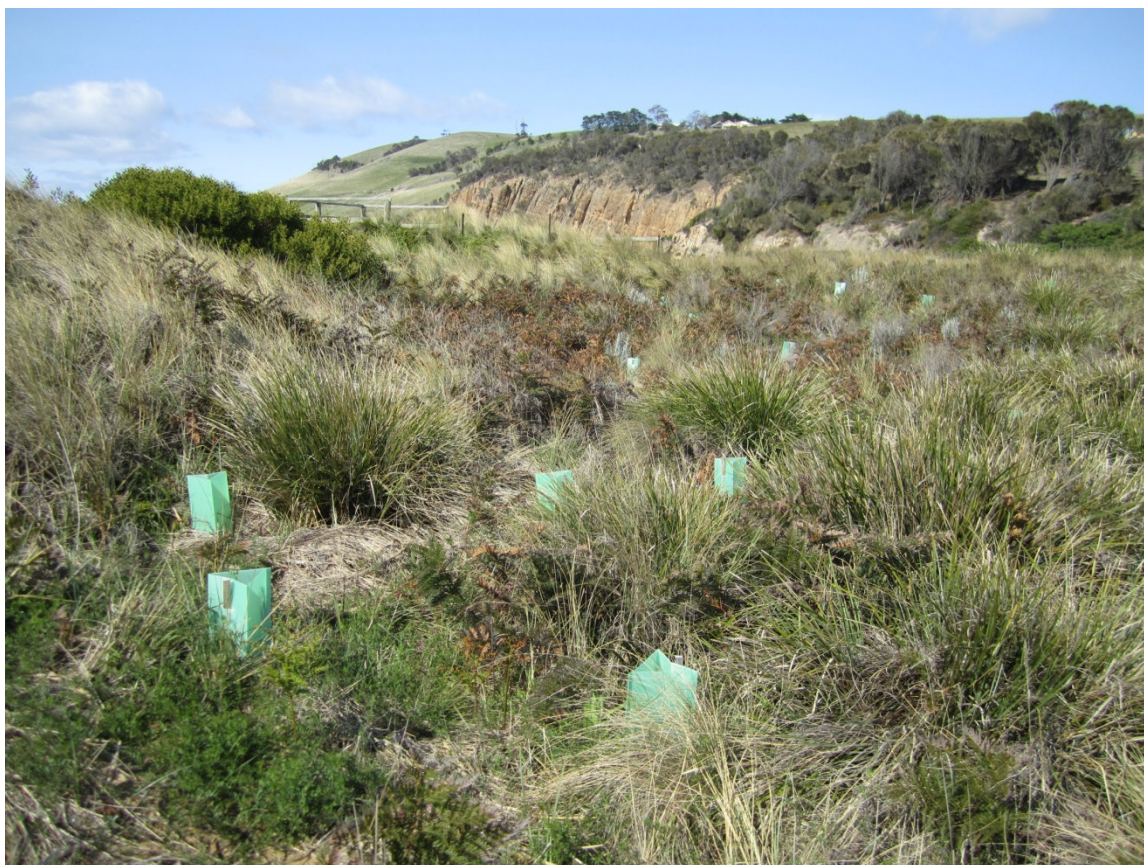
**Figure 2:** Typical vegetation occurring between the car park and Clifton Beach.

The area of vegetation in the dunes between the car park and Clifton Beach, and to the east of the CBSLSC, is classified as regenerating *Acacia longifolia* coastal scrub (TASVEG code SAC). This is not listed as a threatened vegetation community under Schedule 3A of the Tasmanian *Nature Conservation Act 2002*. A description of this community is provided at in Table 1. Typical vegetation in this area is illustrated in Figure 2.

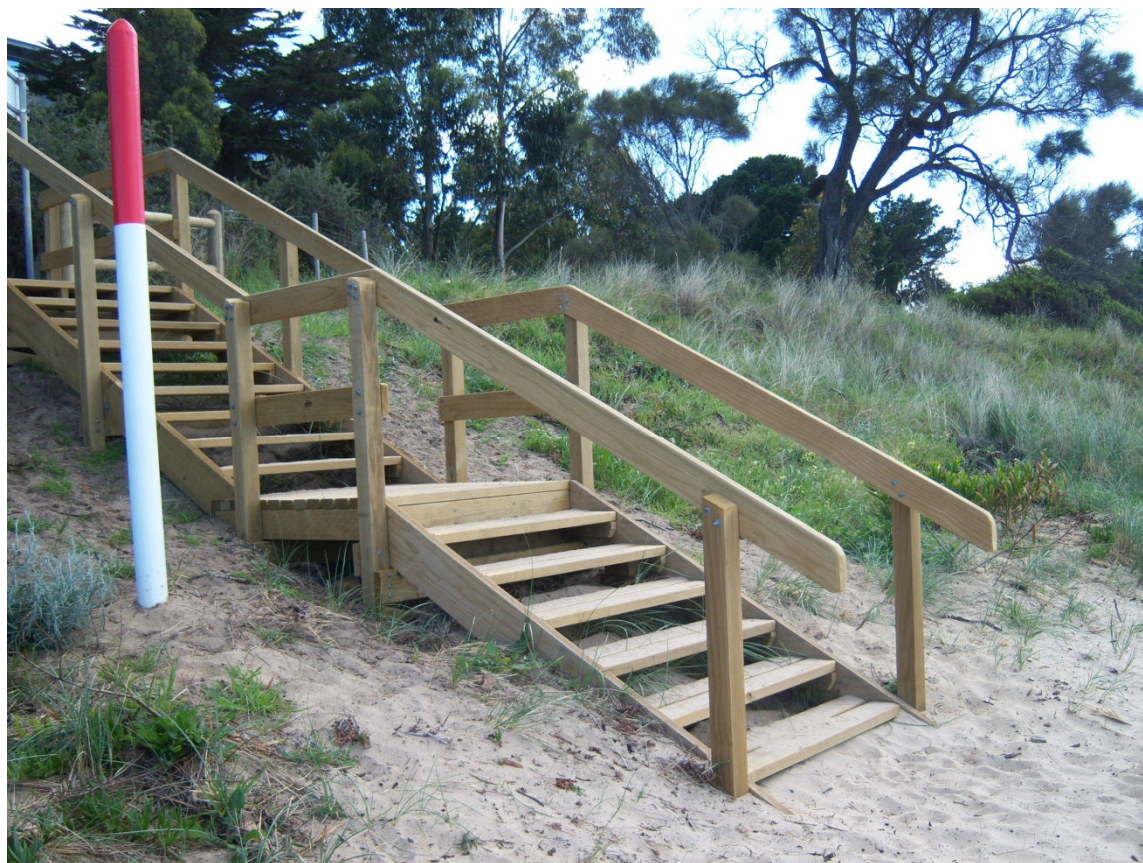
**Figure 5:** Example of an above-dune staircase installed at the Bellerive-Howrah Coastal Reserve.
