CLAYTON'S HOUSE

PLAN OF MANAGEMENT

February 2004

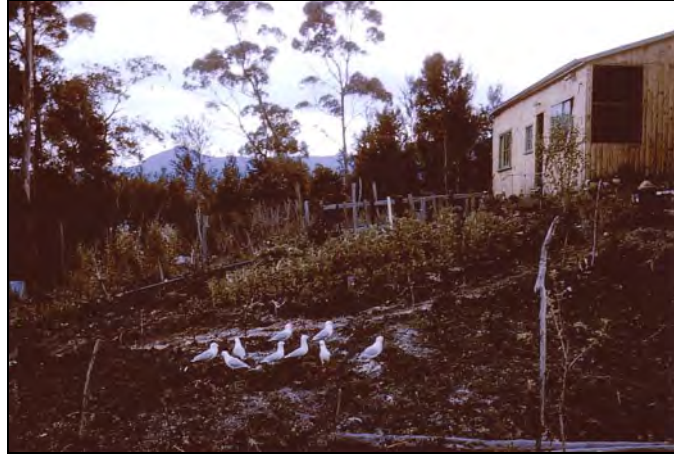
Figure 4: Photo of the house at Claytons Corner taken shortly after construction judging by the 'raw' look of the timber. Note also the garden in its infancy.

The new house had been completed by October 1962 when King transported the King family's old piano from Bond Bay to the new home on his boat, installing it in the main bedroom. The house at Claytons Corner had an identical plan to the Bond Bay house (see Figure 4 and compare with Figure 2).³²

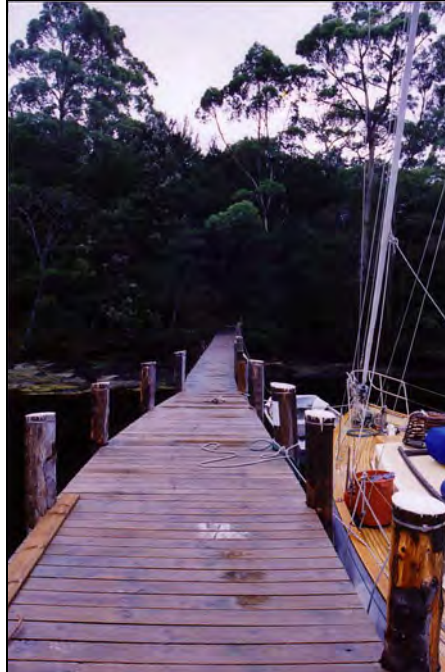
Illustration 1: View along the jetty constructed in 1998. (Photo: D. Parham March 2002).

Access is generally by boat. There is a well constructed jetty (built by Albert Thompson, PWS, in 1998) which replaced the original structure built by Clyde Clayton and Deny King in the 1960s (see Appendix 2 – Illustration 1). Remains of the some of the original jetty piles were deliberately retained as a tangible reminder of the earlier structure. These have been cut off so as not to pose a hazard to visiting vessels. Remains of a former structure (boatshed) are just discernible on the shore immediately east of the jetty (see Appendix 2 – Illustration 2). The roof of this feature is visible in the foreground of Figure 3. The tanks of Clyde Clayton's *Reemere* lie rusting on the bank above the shore.

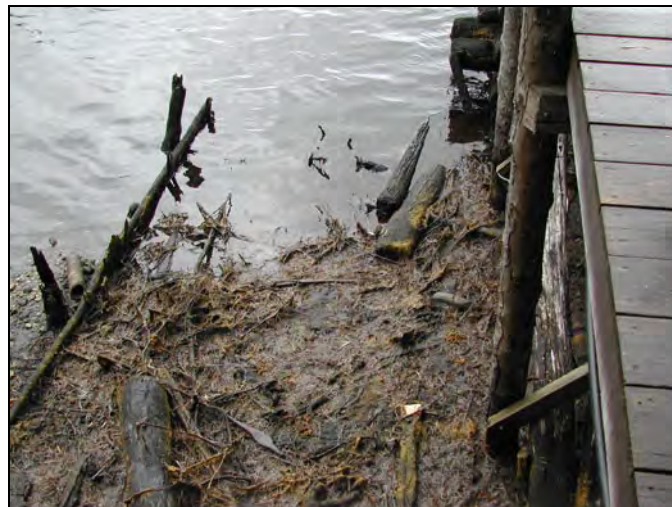
Illustration 2: Site of Clayton's former boatshed. (Photo: D. Parham, March 2002).

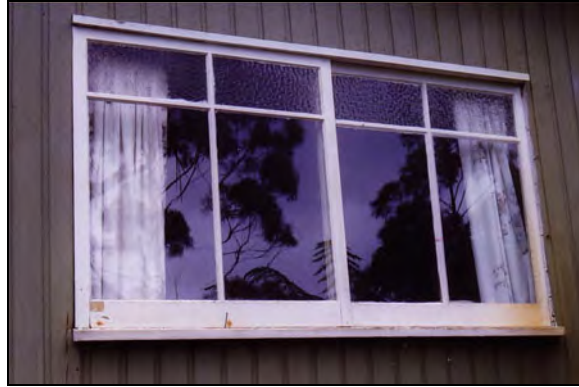
Illustration 4: Window to the lounge north of the door in the east wall (this is W1 in Appendix 4).
(Photo: D. Parham, March 2002).

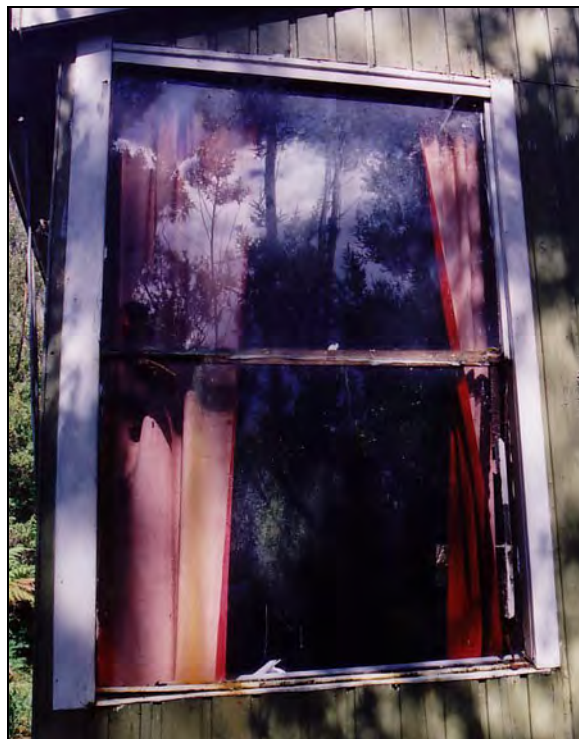
Illustration 5: Window to lounge in north end wall (this is W2 in Appendix 4). Note: The entire north wall has been replaced and a new window to match the original (pictured above) is being fabricated.
(Photo: D. Parham, March 2002).

- Install glazing to new north wall (lounge room) window to match original.
- Install glazing to bathroom window to match original.
- Ensure seals around all windows are intact and rectify as necessary.
- Repair external cladding to laundry porch wall to match west wall cladding.
- Complete external painting (commenced in March 2003).
- Extend external spoon drain along the base of the north wall.
- Complete underfloor stump assessment and rectify as necessary.
- Repoint brickwork forming the external chimney firebox.
- Treat rust on external prefabricated steel flue assembly with an approved metal preservative.
- Connect spouting on west side of house to new tank installed in March 2003.
- Install bath and sink outlets to control grey water.
- Install leaf guard to gutters.
- Ensure that roof is not leaking (check that rain is not being blown under ridge cap).

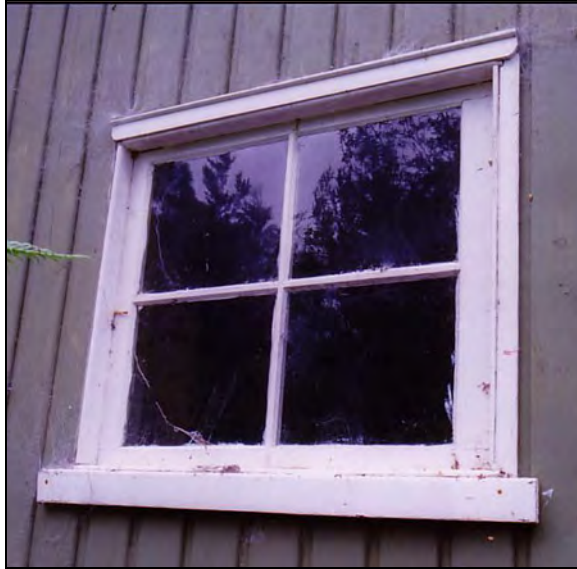
Illustration 6: Window to the kitchen south of the door in the east wall (this is W3 in Appendix 4).
(Photo: D. Parham, March 2002).

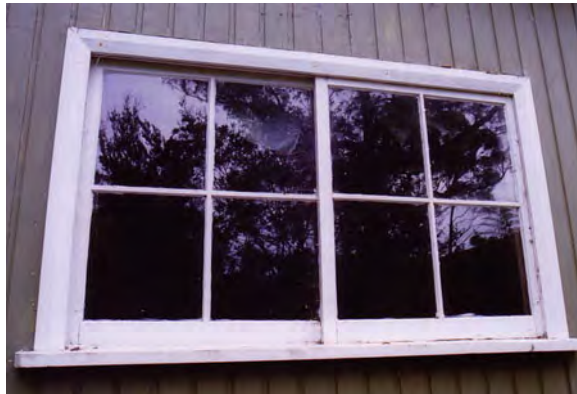
Illustration 7: Window to the main bedroom (BR 1) set in the southern half of the east wall (this is W4 in Appendix 4). (Photo: D. Parham, March 2002).

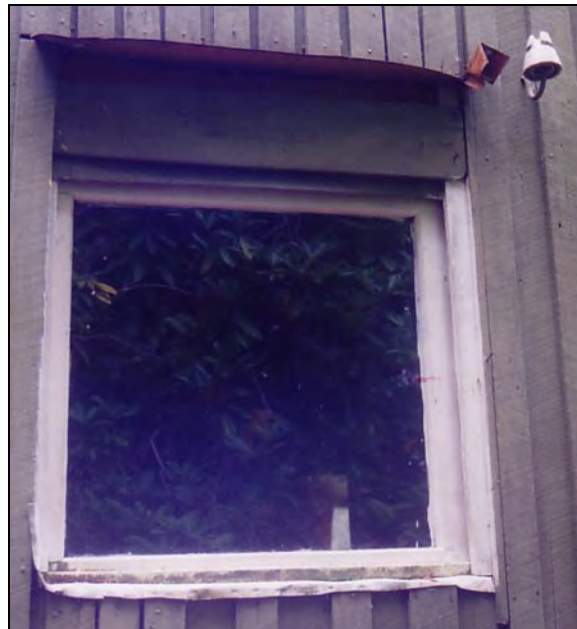
Illustration 8: Window to the second bedroom in the south wall (this is W5 in Appendix 4). (Photo: D. Parham, March 2002).

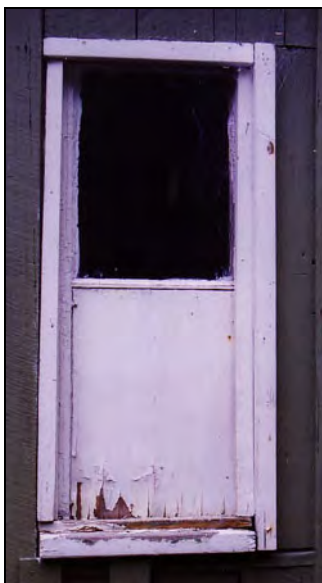
Illustration 9: Window to the bathroom in the west wall (this is W6 in Appendix 4). Note: A new window to match the original (pictured above) is being fabricated.

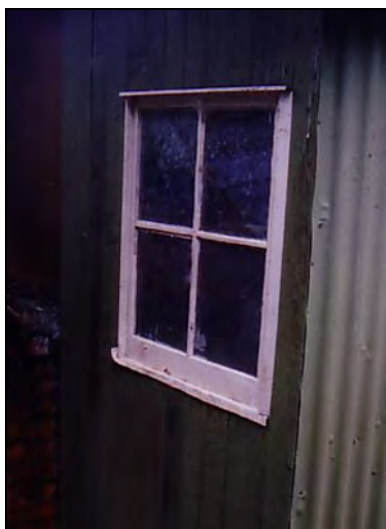
Illustration 10: Window to the laundry set in the north end of the west wall.

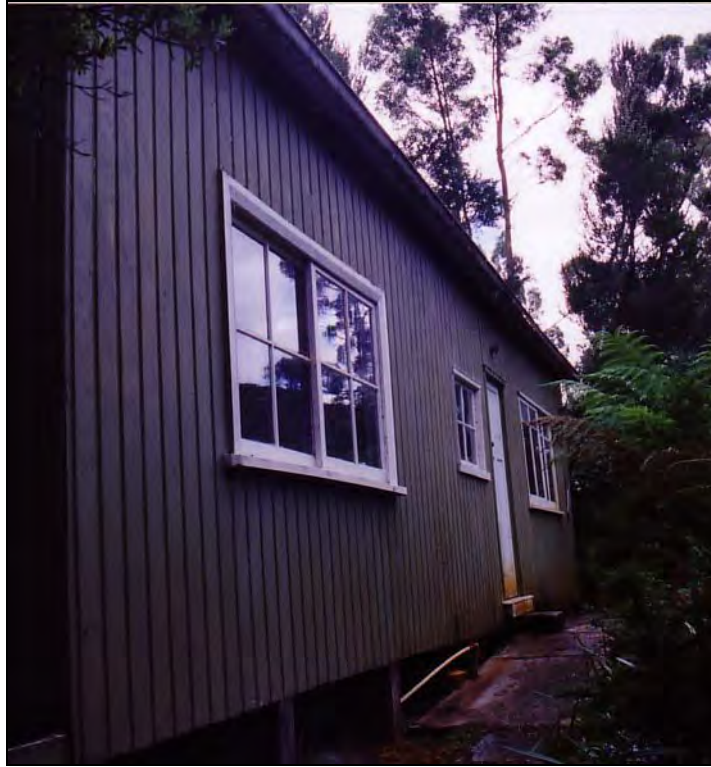
Illustration 11: View of the front of Clayton's House (eastern elevation looking north) taken prior to painting in 2003.

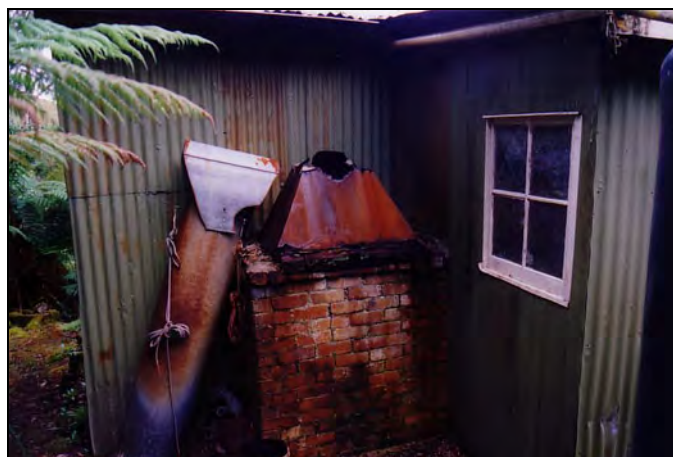
There is an external chimney located in the west wall return at the northern end of the building. The brick base is original, however, the flue assembly has been replaced (see Appendix 2 – Illustrations 12 & 13 for views of the original flue and its replacement).

Illustration 12: View of the original external chimney showing the flue assembly which was part of the intake at the Ray River mines until it was salvaged and adapted for domestic use by Clyde Clayton.

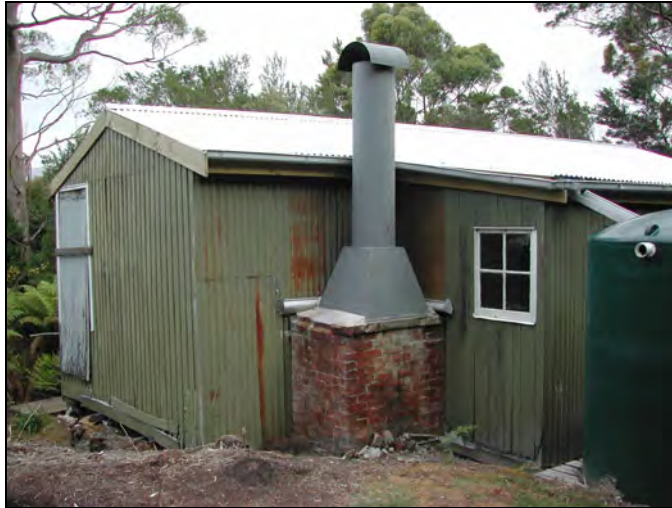
Illustration 13: View of the new flue assembly installed during PPF works in 2002.
(Photo: D. Parham, February 2003).

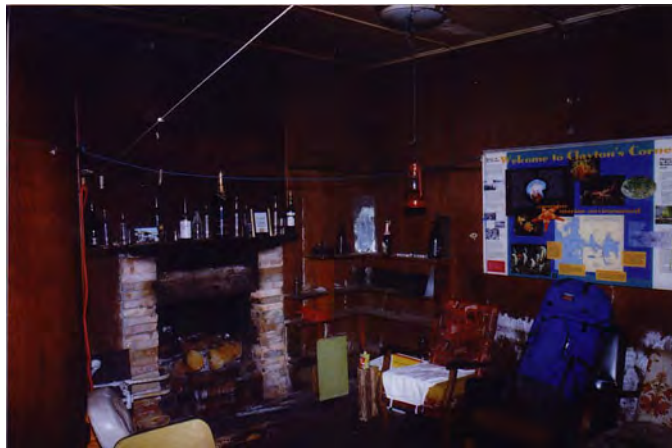
Illustration 14: Ply lining in the lounge room. (Photo: D. Parham, March 2002).

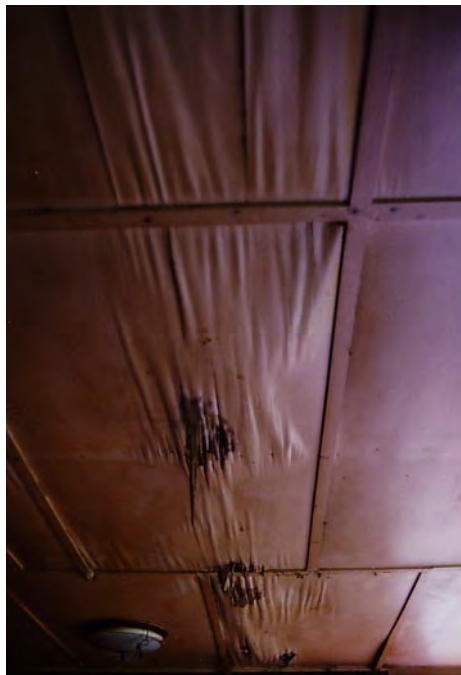
Illustration 15: Rot in ply ceiling in lounge. (Photo: D. Parham, March 2002).

- Implement fire safety measures as a priority on receipt of appropriate, specialist, advice.
- Selectively replace missing, badly delaminated or rotten ply linings with new sheets. Apply philosophy of ‘as much as necessary as little as possible’ to decision making on what to replace. Paint new sheets for lounge ceiling only (semi-gloss - white) and discreetly date. Stain new sheets only in remainder to match existing and discreetly date. Replace battens and/or ‘D’ mouldings as required and otherwise fix or reattach with 20mm flat head (box) nails.

Note: Prior to replacing ply lining/s to ceiling ensure the roof is not leaking. Check also that rain is not being blown under the ridge cap.

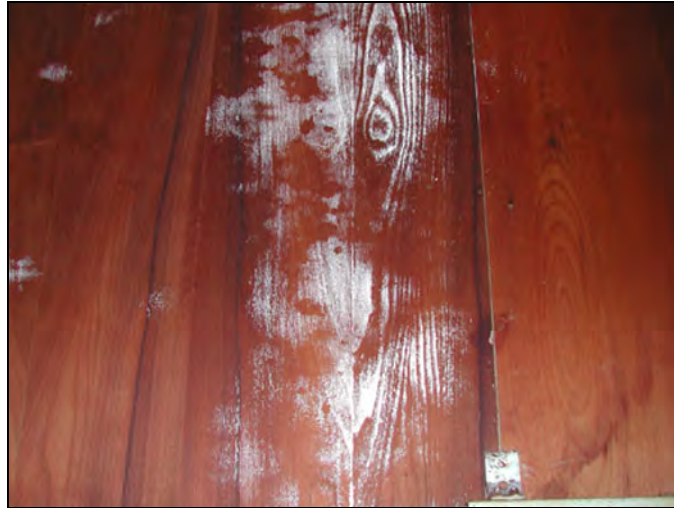
Illustration 16: White powdery substance (fungus?) that covers some of the ply linings in the house.
(Photo: D. Parham, February 2003).

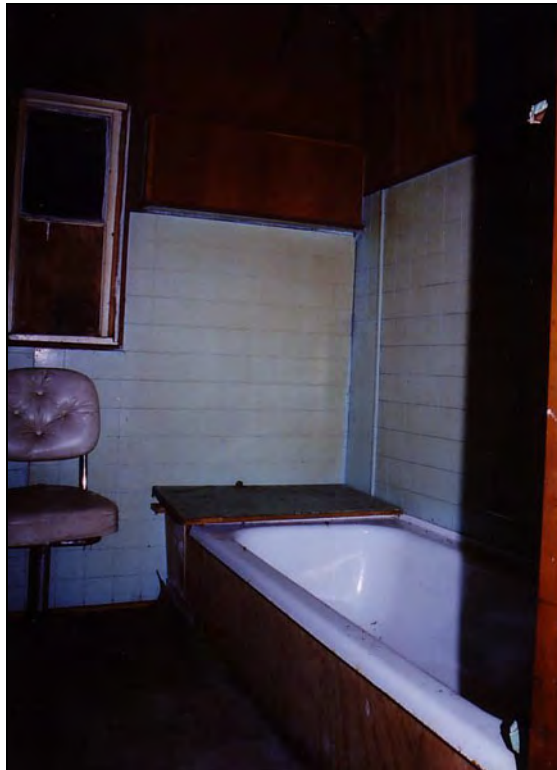
Illustration 17: Bathroom showing vinyl tiles and bath. (Photo: D. Parham, March 2002).

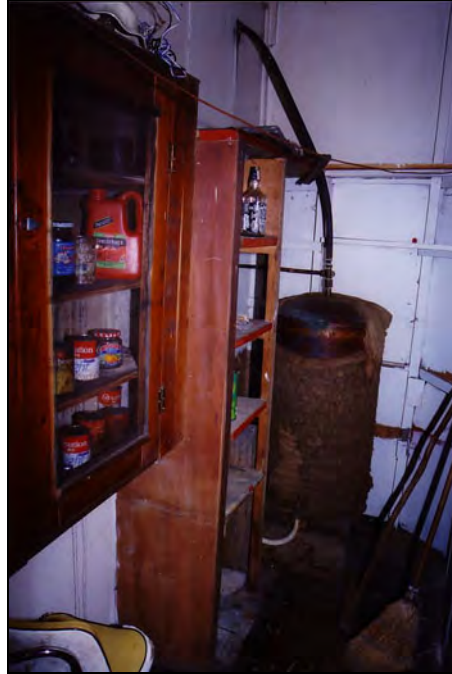
Illustration 18: Inside 'the wheelhouse' in the lounge showing the hot water system relocated to this position after the Clayton's had left . Note also the glass fronted storage cabinet and bookcase.

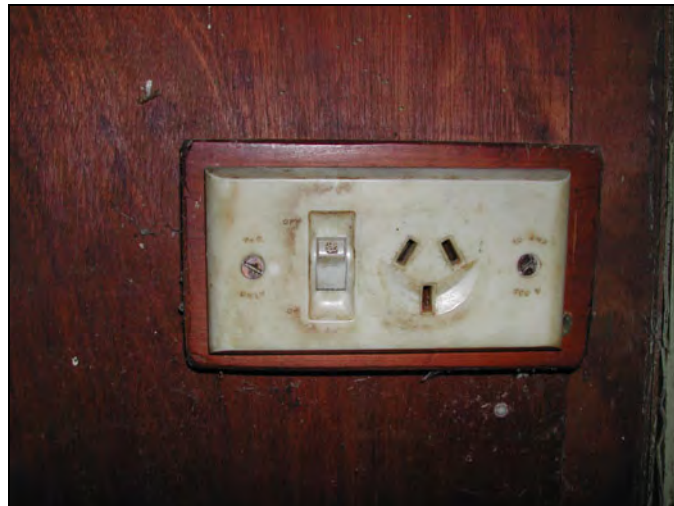
Power was supplied by a generator and some of the original powerpoints and switches survive (Appendix 2 – Illustration 19). An original light fitting remains in-situ in the lounge ceiling.

Illustration 19: Original powerpoint detail. (Photo: D. Parham, February 2003).

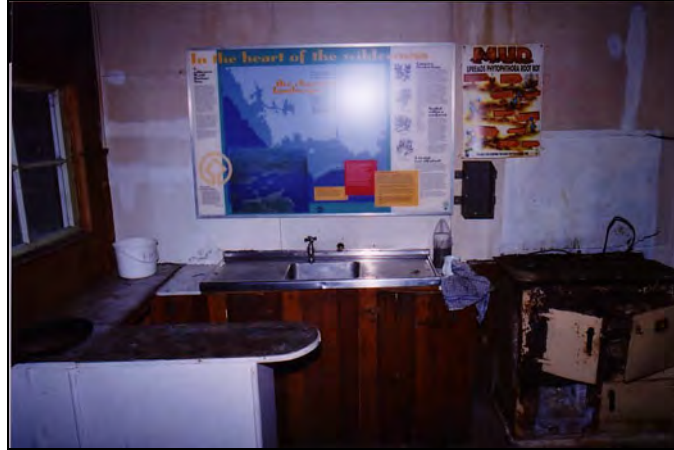
Illustration 20: The kitchen bench and sink unit . Note also the Rayburn Stove which has since been removed from the site.

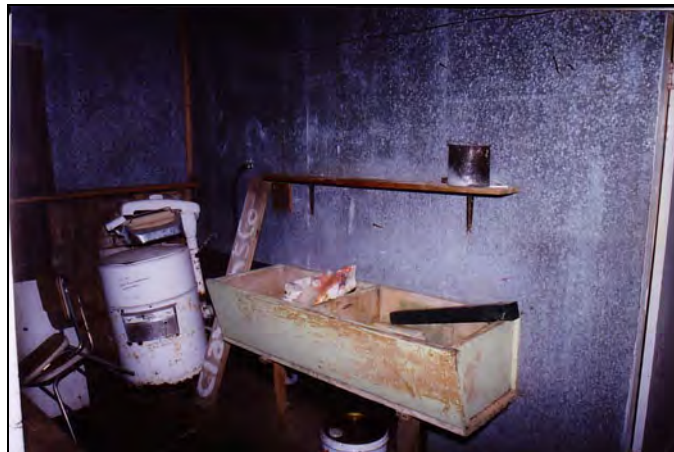
Illustration 21: The Huon or Kauri pine laundry trough and washing machine. Note also the flat iron lining to the laundry/lounge room wall.

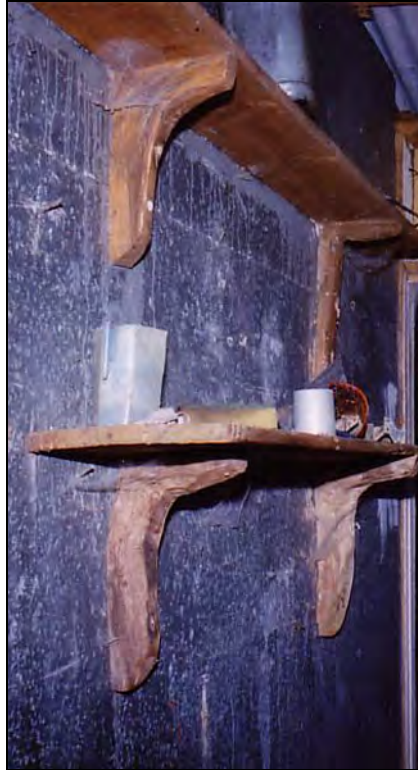
Illustration 22: Laundry shelves supported on tree 'knee' brackets made by Clyde Clayton.
(Photo: D. Parham, March 2002).

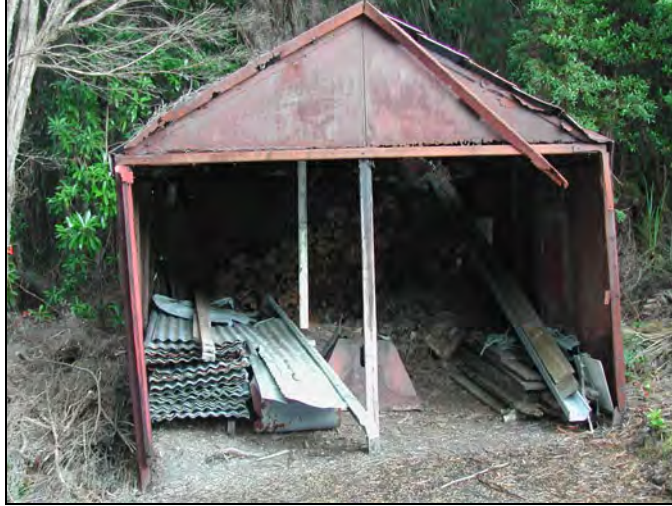
Two Wiles brand garages (relocated to this site from the Clayton's first home at Bond Bay) remain extant although they are heavily corroded and structurally unsound (refer to Appendix 5 for engineers report). The shed closest to the jetty (Appendix 2 – Illustration 24) housed the generator whereas its counterpart opposite the rear of the house (Appendix 2 – Illustration 25) was used for wood and general storage. The original external flue assembly, “Steri-lid” toilet (Appendix 2 – Illustration 26) and corrugated aluminium roofing iron removed during PPF related works in 2002 are currently stored in the sheds.

Illustration 24: The former generator shed. (Photo: D. Parham, February 2003).

The two Wiles garage type outbuildings (also known as the generator and wood shed/s) have been assessed by an engineer and declared unsafe. The engineers report (see extract included as Appendix 5) recommends fencing the area off pending either removal or 'restoration'. Future use of the outbuildings for any purpose is subject to those structures being certified as safe by a suitably qualified engineer.

- Initiate as a matter of priority a process to determine the future of the generator and wood shed/s (refer to s6.2.2 for recommended process and heritage imperatives).

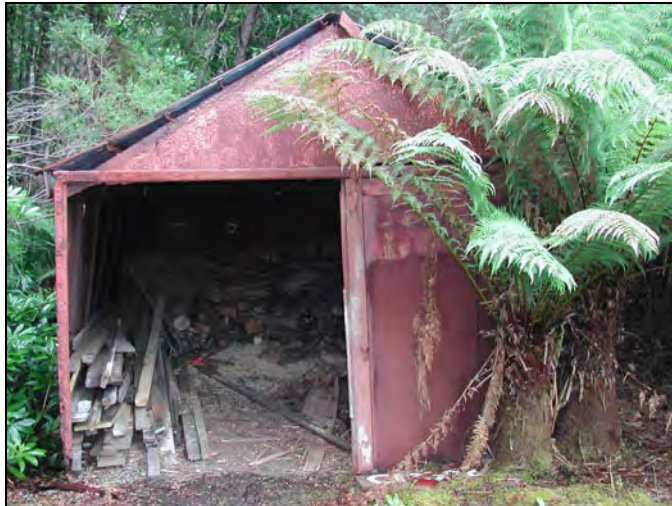
Illustration 25: The wood shed. (Photo: D. Parham, February 2003).

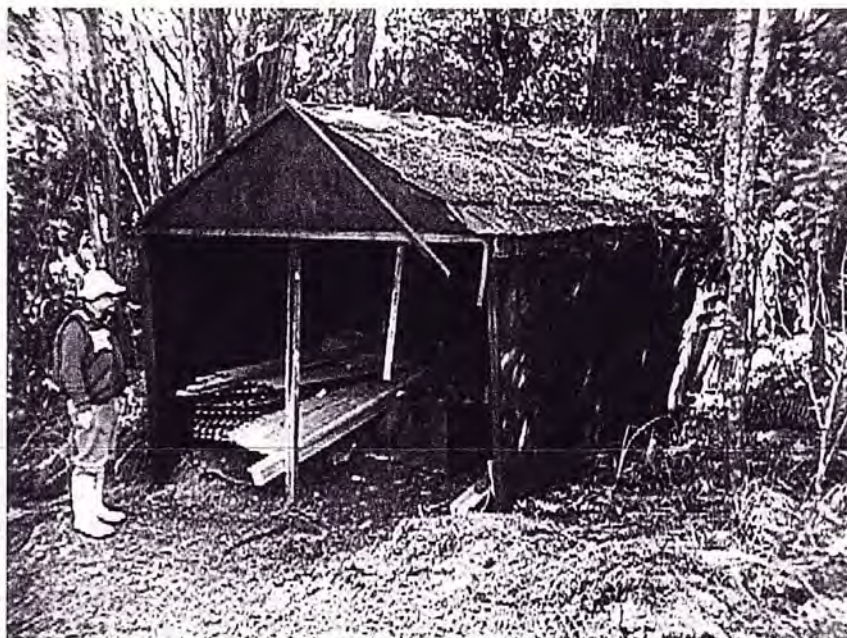
■ Woodshed

- The sheds are of a prefabricated, all steel construction. Their size and configuration indicates they were originally design to be used as garages.
- Both sheds are completely coated with rust . The press metal frame and wall sheeting has many areas which are severely corroded.
- The shed framing relies on the wall and roof sheeting for structural stability.
- Both sheds sway substantially when loaded by one person lightly pushing on the walls. It appears the timber and debris stored in the shed is supporting the shed.

The sheds are in very poor condition. They are likely to collapse at any time. The area should be immediately fenced off until a decision is made whether to remove the sheds from site or restore. We understand the sheds are of historical value to the area and are being programmed for restoration. It is our opinion, due to the extent of the corrosion, most of the original shed elements could not be restored and will need to be replicated.

Alternately, the sheds could be made safe by installing a new internal structural frame that doesn't rely on the existing shed for any support.
